2019 Equipment Check Centre County Pennsylvania Senior Environmental Corps

CCPaSEC Quality Control Team
February 2019

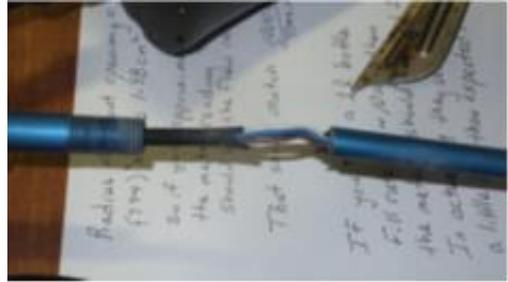
FlowWatch flow velocity meter. Three of the meters had been repaired to fix the small turbine (propeller) to the black tube and one had expose wires in the wand (photos below).

Photo showing the Flowmeter turbine tips and repairs.

All repaired units functioned well however, we observed that some of the epoxy used to repair one (Kit 1) was evident in the black sleeve. Another had foreign material in the sleeve. That material would increase the spacing between the turbine (little propeller) and the magnet pick-up in the wand. Too much material may cause the magnetic pick-up to mis a pulse and cause inaccurate results. We are not presently able to reliably measure actual flow through the turbine.

The exposed wires were taped with electrical tape and slid back into the wand. Rob Fugate will attempt to enhance this temporary "fix" at home.

Please notify Dan DeLotto if a repair or replacement is needed. Permeant repairs should be made with epoxy appropriate for use with plastic by Dan DeLotto or another member of the Quality Team.

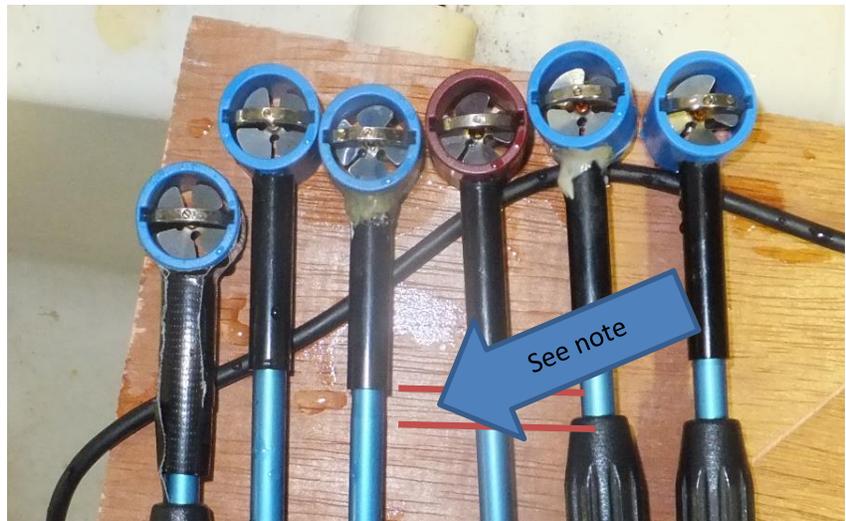
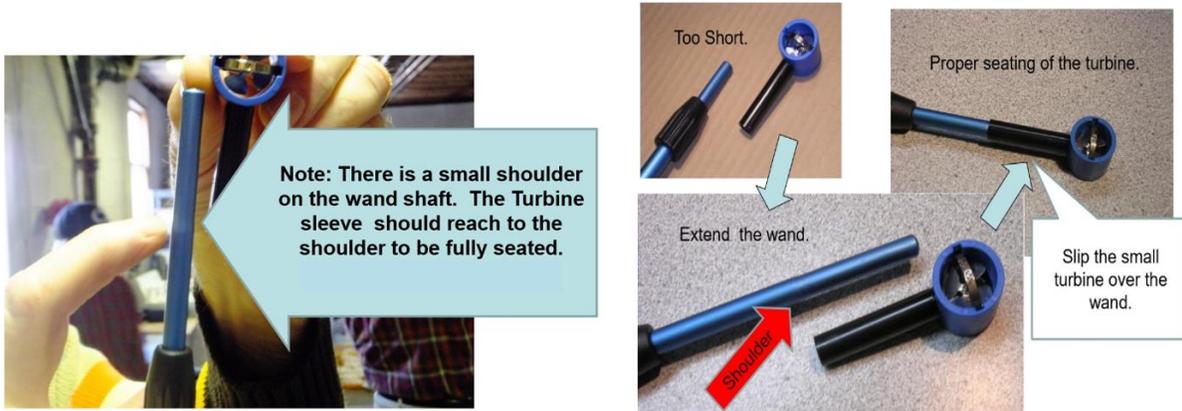
Note: The turbine (propeller) could not be seated

Please determine that black sleeve is free of internal debris any time it is removed from the wand.
