2019 Equipment Check Centre County Pennsylvania Senior Environmental Corps

CCPaSEC Quality Control Team
February 2019

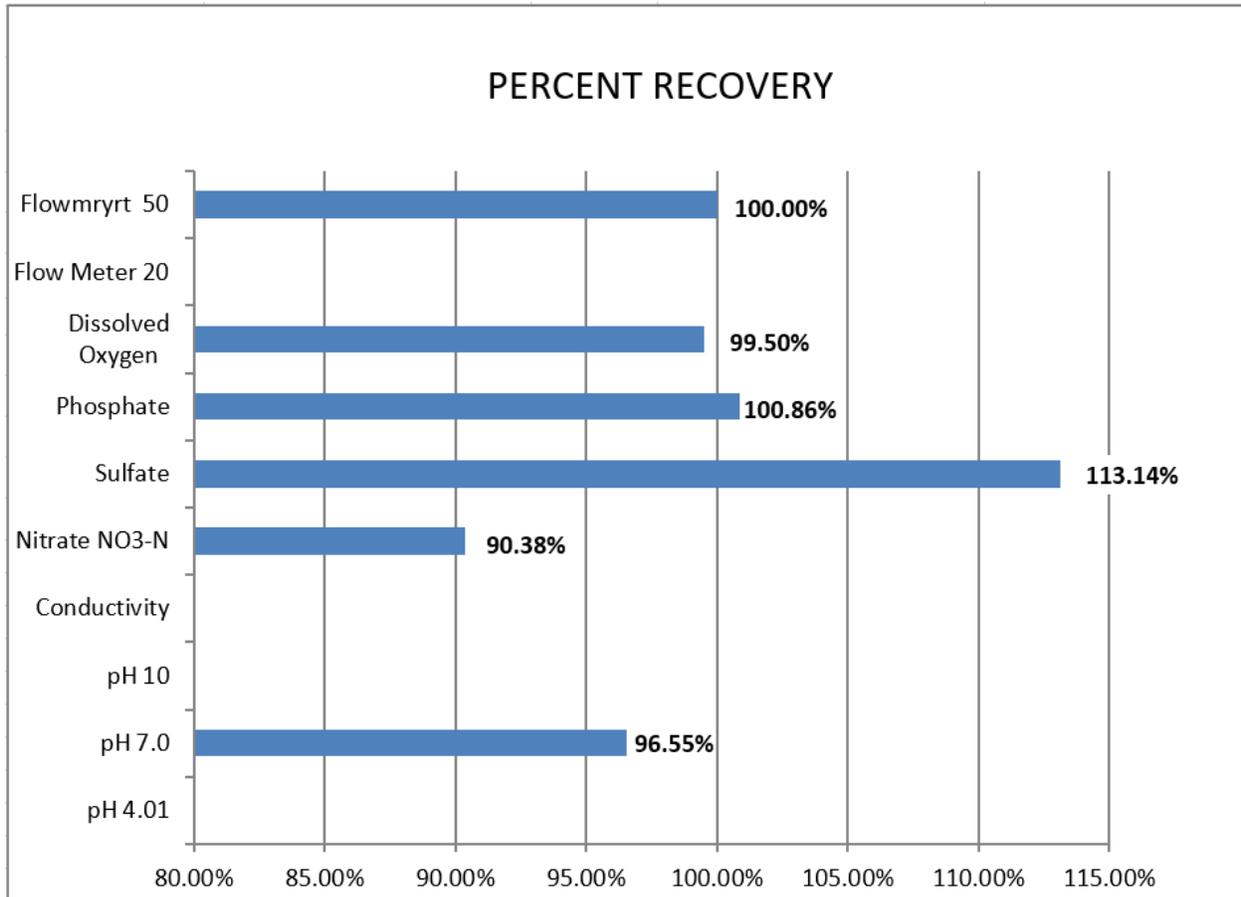
We did not determine PR for pH for the range of 4.01 or 10.0 this session.

Conclusion: The PR for sulfate exceeded our guidelines. The results indicate our field equipment is limited. We are not using Laboratory certified equipment and we cannot expect Laboratory level results. The percent recovery of our equipment is consistent with previous years. The Nature Abounds QAP states that “If the absolute difference is greater, corrective action will be taken to improve performance.
